SIMILARITIES BETWEEN EARLY OTTOMAN ARCHITECTURE AND LOCAL ARCHITECTURE OR BYZANTINE ARCHITECTURE IN IZNIK

E. F. ALIOGLU

Associate Professor, Yildiz Technical University, Istanbul, Turkey

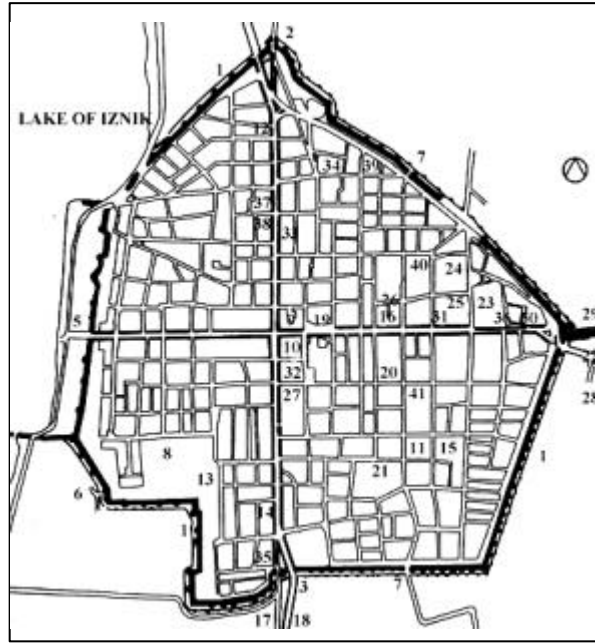
Figure 1: Iznik City Plan: Buildings of the Antiquity, the Byzantine Period, and the Ottoman Period (Source: Schneider, Eyice, and Çakmakçı)

It is not known what the characteristics of the road pattern were when Iznik was captured by the Ottomans. However, it can be deduced that Early Ottoman buildings were located in reference to the Hellenistic road pattern (Figure 1). Murat I Double Bath (XIVth-XVth centuries) and Mahmut Çelebi Mosque (1443) were sited on the street between Istanbul Gate and Yenisehir Gate; Hacı Özbek Mosque (1333, 1334) and Hacı Hamza bin Ardunsah Mosque (1343-1346), the tombs of Çahdarlı Halil Pasa (d. 1453) and of Çandarlı Ibrahim Pasa (d. 1429) were built on the streets between Lake Gate and Lefke Gate, the street which is perpendicular to the other main street. Many other buildings were located on the corners or along the crossing Hellenistic roads, thus presenting plan schemes which indicate development in the north-south or east-west directions. Additionally, in some examples like Hacı Özbek Mosque, Hacı Hamza Mosque and Nilüfer Hatun Soup-kitchen (1388), the fact that the masses of these buildings do not turn toward Mecca, shows the influence of the already existing
